Title: **QUALITY AUDIT**

Road Safety Audit, Access Audit, Cycle Audit and Walking

Mixed Use Development at Former Blakes and Esmonde

Motors Site, Stillorgan Co. Dublin.

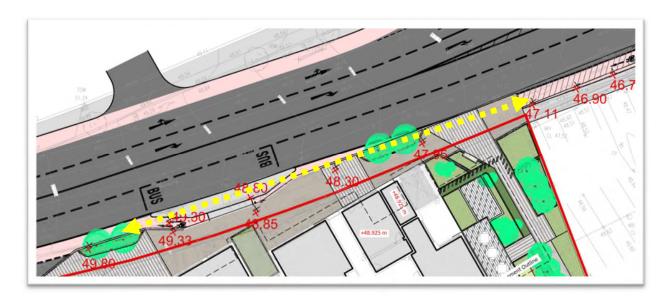
There is a discontinuity in the cycle facilities along Kilmacud Road Lower. This will lead to cyclists sharing space with pedestrians and to some cyclists opting to enter the carriageway. This could increase the risk of cyclists being struck by passing vehicles on the busy four lane road.

It is recommended that that a cycle track of constant width be provided along the full length of the development with perhaps only a slight throttling at the bus stop area where pedestrian have to cross in line with BusConnects standard details.

3.1	Yes	Yes	See attached updated drawing No. 20-071-P111. The drawings has been updated to reflect a continuous cycle lane except for one section which the cycle lane is broken to allow pedestrians leaving a bus at the bus stop to cross to the footpath	Yes

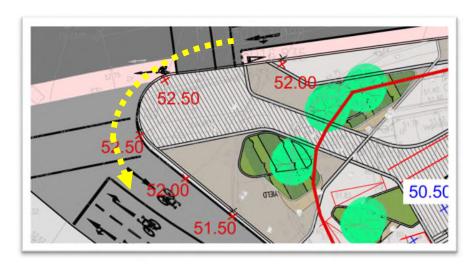
It is unclear if a heavy goods vehicle will be able to undertake the acute left turn from Lower Kilmacud Road to The Hill without entering the right turning lane or crossing the stop line. If this manoeuvre cannot take place this could lead to sudden braking and rear-end collisions.

It is recommended that a swept path analysis be carried out to ensure that the manoeuvre can be easily undertaken. If necessary, the stop line on The Hill should be set back.

3.4	Yes	Yes	Please see attached Waterman Moylan Drawing No. 20-071-P176	Yes

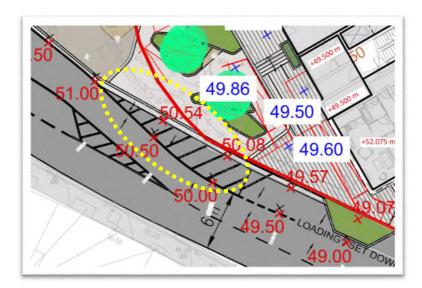
There is a risk that the hatched area in advance of the loading bays/set-down area on The Hill will be used as a parking area for those using the retail units on the opposite side of the development. This could lead side-swipe collisions of passing vehicles.

It is recommended that a solid buildout be provided to avoid parking and to help define the road layout for drivers.

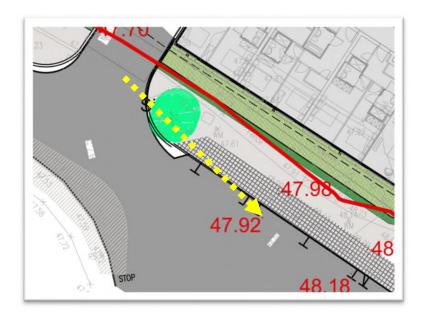
There are 4 no. car parking spaces to the south east of the south basement access on The Hill. Vehicles parked int these spaces may block a drivers visibility to their left as they exit the basement.

It is recommended that the spaces be provided outside the visibility splay.

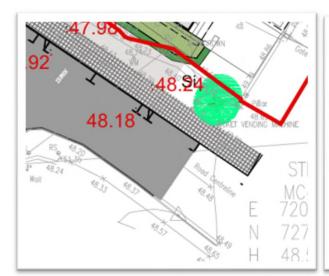
There is a risk that visitors driving to the development, unfamiliar with the area, may not realise that they cannot continue south on The Hill beyond the Glenalbyn Road junction as it is primarily a one way road except for Gardaí. A lack of warning could lead to drivers travelling south resulting in side-swipe collisions with northbound vehicles or in extreme circumstances wrong way driving on the N11 dual carriageway.

It is recommended that additional warning signage and road markings be provided at the Glenalbyn Road junction so that drivers do not travel beyond the junction and do not have to U-turn.
