**Arboricultural Report
Trees at Proposed Site at
Blake's Restaurant
Stillorgan
Co Dublin**

March 2022

**The Tree File Ltd
Consulting Arborists
Ashgrove House
26 Foxrock Court
Dublin 18
D18 R2K1
086-3819011**

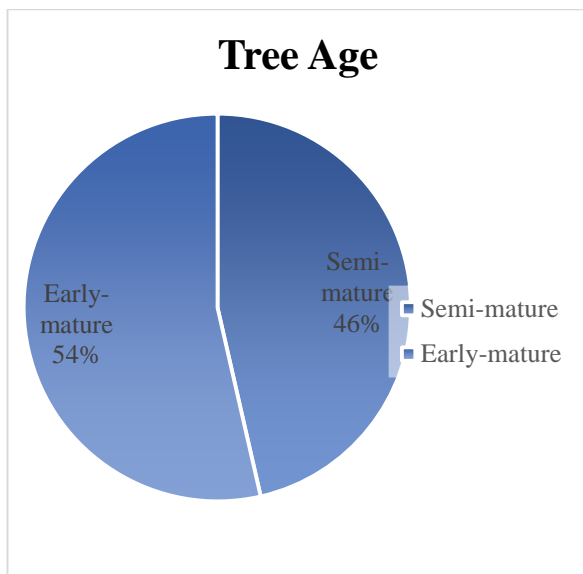
Fig 3

4.7 As noted above and illustrated by the tree age graphic as Fig 3, the sites tree population is dominated by young trees. This does not appear to relate well to sustainability with more than 70% of trees falling into categories “C” or “U” and more than 40% of trees offering short or no realistic sustainability.

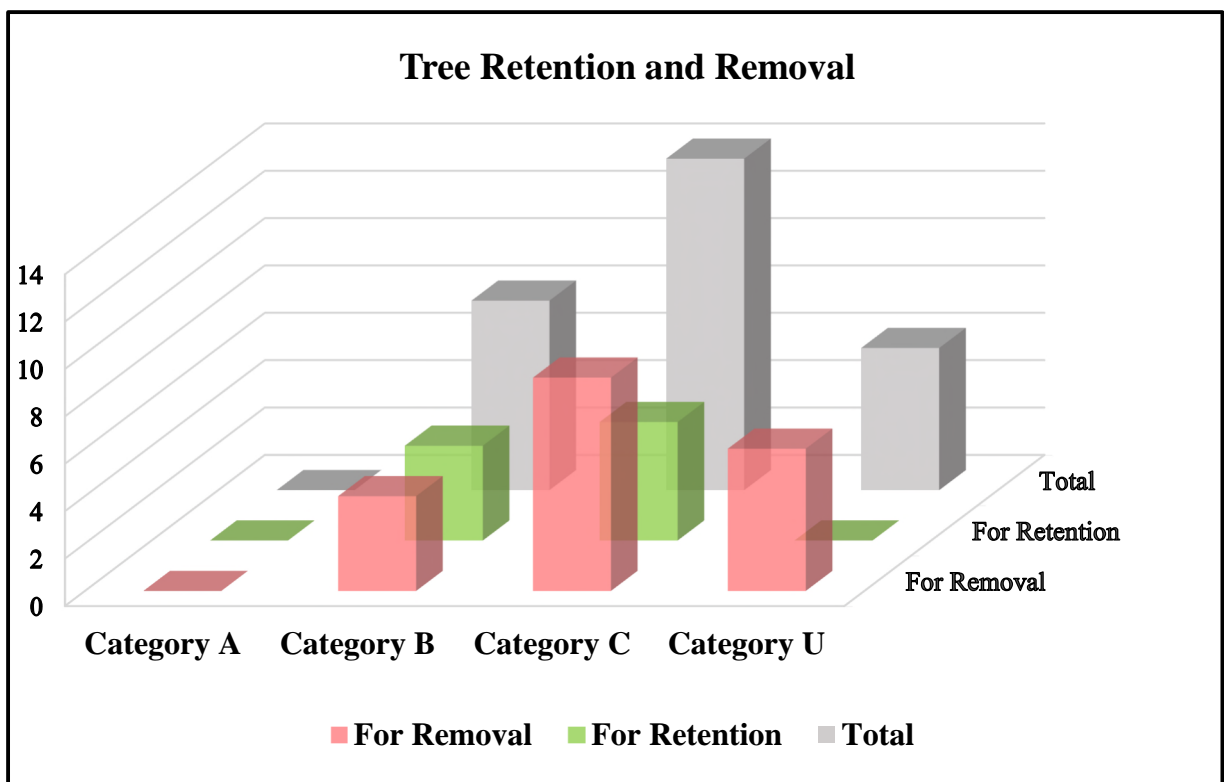
Fig 5 Graphic Representation of Tree Loss/Retention Scenario

12.4 Of the site's good quality category "B" trees, the development will result in the loss of tree nos.93, 96, 98 and 99.

12.5 Of the site's category "poor" quality "C" trees, the development works appears to require the removal of nos. 94, 95, 97, 100, 106, 111, 112, RS1 and RS2.
